SURVEILLANCE

AND INSPECTION REPORT

Project Name: True North Stage 21

Location: Lysterfield Drive Greenvale

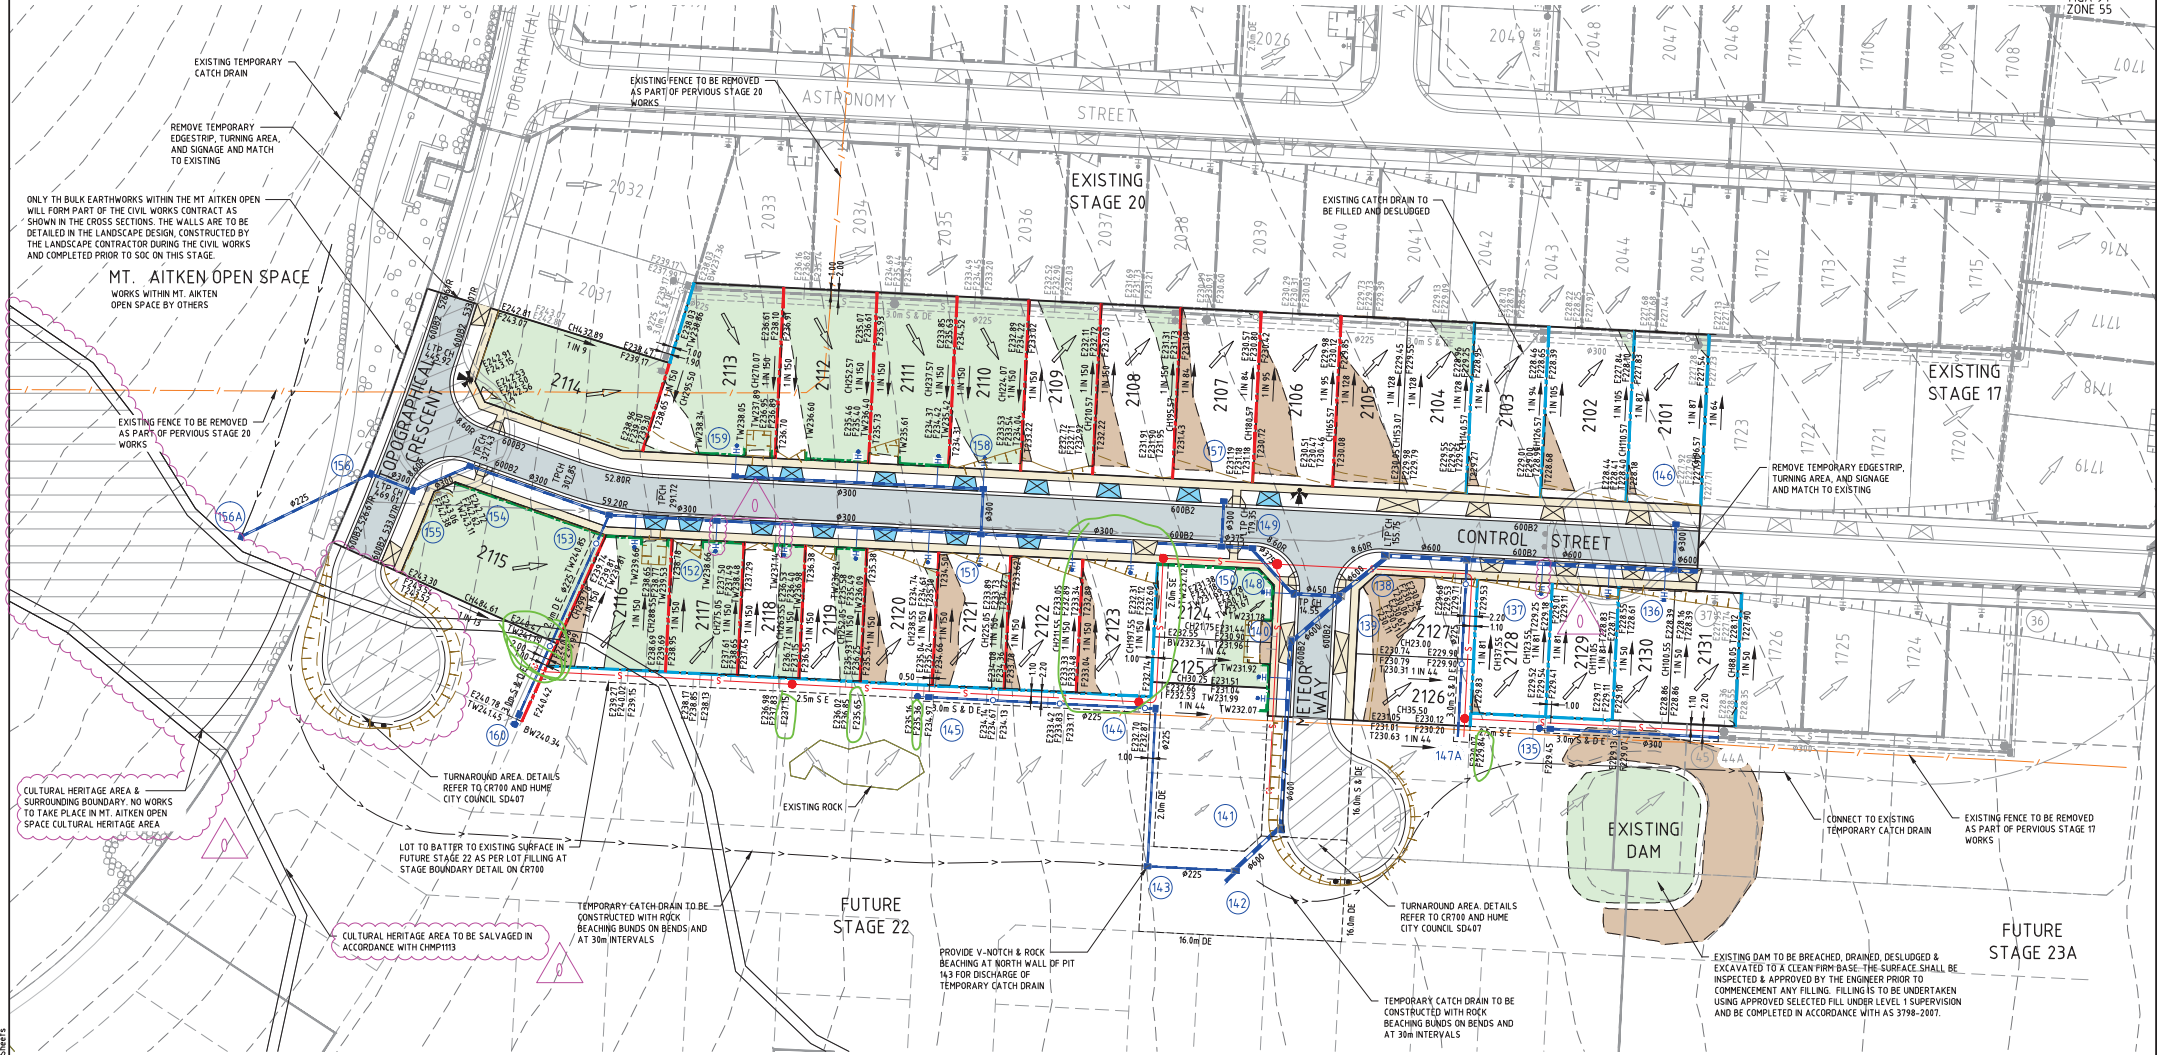
CONSTRUCTION 303051CR200 0

(1). Detail Plan Drawing No. 303051CR200 (Rev 0).

**TRUE NORTH
STAGE 21
ROAD AND DRAINAGE
ROAD LAYOUT PLANS
HUME CITY COUNCIL
SATTERLEY PROPERTY GROUP PTY LTD**
