Level 1 Report – AS3798

Client: Shadforth Civil
Project: Ridgeview Stage 12, Narangba
Job No: J24/26
Docket No: 58054
Developer: Satterley Property Group Pty Ltd
Consulting Engineer: Colliers

Wagner Soil Testing has recently completed a Level One Overview of Earthworks, in accordance with the requirements of AS3798 – “Guidelines on Earthworks for Commercial and Residential Developments” for Ridgeview Stage 12, Narangba.

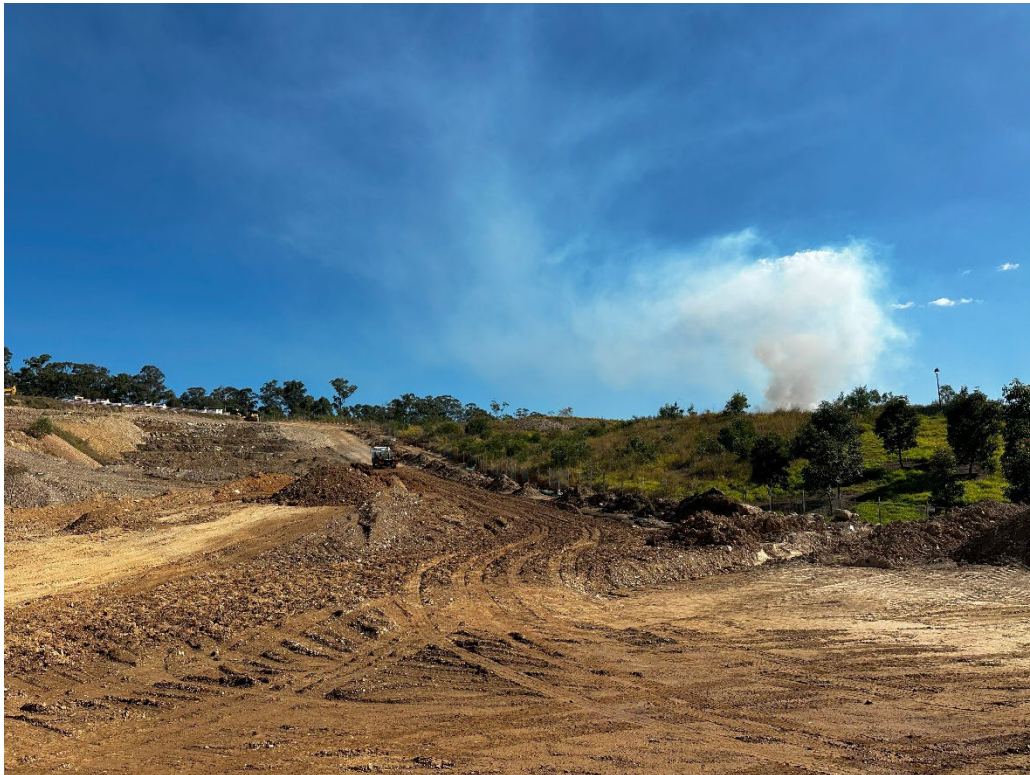
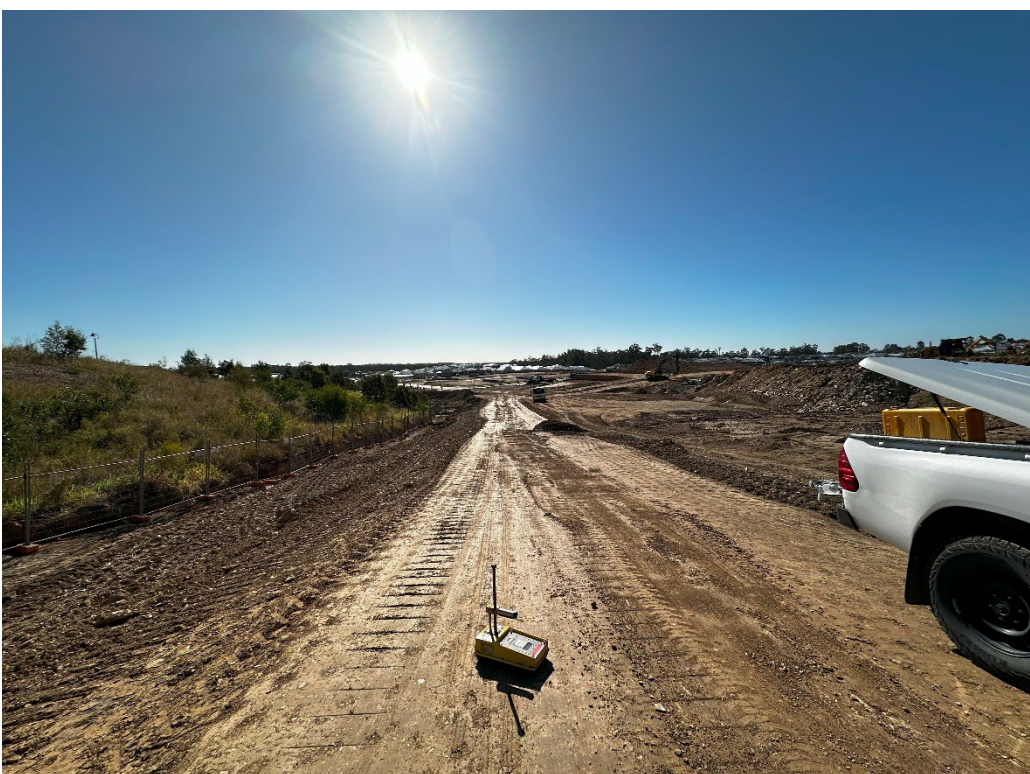
Appendix 3: Typical Site Conditions

Fill materials (on-site) were compacted using a medium sized pad foot roller in layers not exceeding 0.3m loose. The natural ground in the areas of filling generally comprised of Gravelly Shaley Clay (Cl). The fill material used was generally as above. Moisture contents of all fill material placed was monitored by Wagner Soil Testing. Total volumes of fill reached 11589m³.
